# SGPC Temporary Roads Monitoring Pilot Project

## **Introduction:**

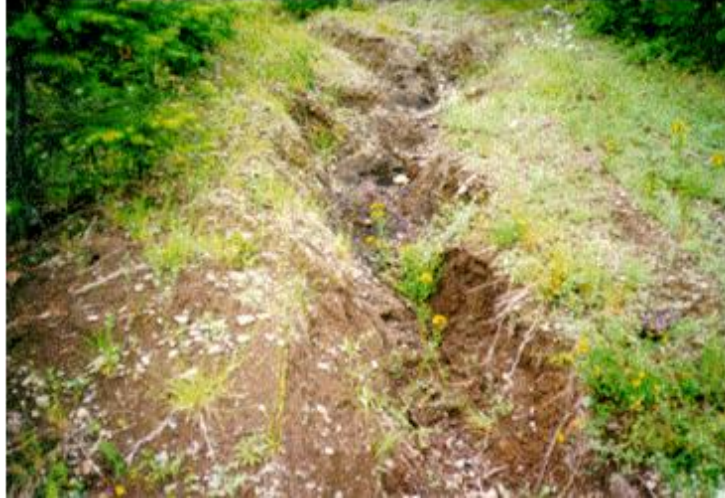
Example of erosion (deep gully). Photo from MARD Road Decomm Monitoring Report.

- 5) Does the roadbed match the natural contour of the slope? Is there evidence of cut & fill? If cut banks present, what is average height?
- 6) Is there evidence of erosion? Are there channels formed (gullies, rills) from running water? *Take a Photo of beginning and end.* For each gully or rill, please identify amount of erosion on roadbed: paced length, average depth, average width. Measure by pacing rills/gullies. Describe location, where they start and end.

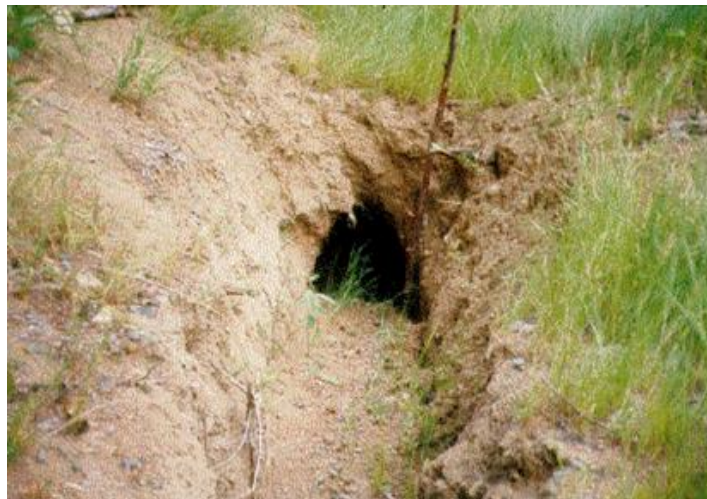
Example of culvert section and associated fill that was not fully removed. Photo from MARD Road Decomm Monitoring Report.

- 7) If the road was waterbarred, does it appear effective at routing water off the road surface and reducing surface flows along inside ditches? (I.e. did you see erosion nearby?) Were they constructed all the way across the road surface to the cutslope? *Take a Photo of beginning and end.*
- 8) Are there fill failures or washouts forming? *Take a Photo of beginning and end.* Please identify each occurrence.
- 9) Are there stream crossings or ditch relief crossings? *Take a Photo of inlet and outlet.* Ditch relief crossings move water from one side of the road to the other. Identify if the pipe and the corresponding road fill was removed. Is there erosion or failure?

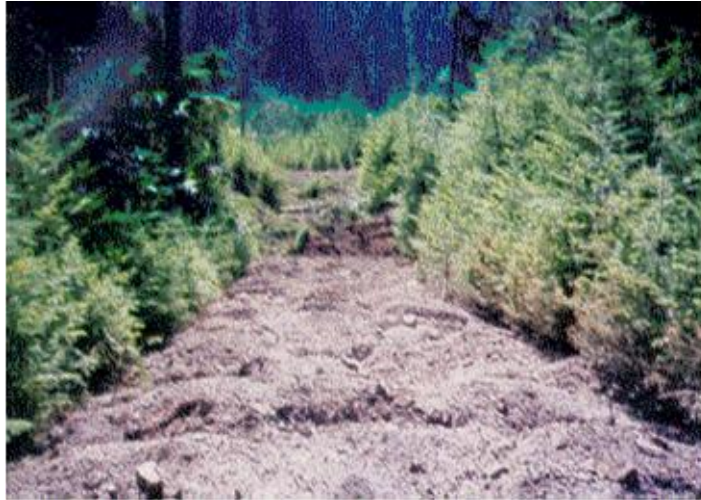
Example of hummocky surface on a road immediately after scarification by an excavator bucket. Photo from MARD Road Decomm Monitoring Report.

10) Are there signs of ripping or scarification of the road (soil has been lifted and well fractured; lumpy, uneven or varied)?

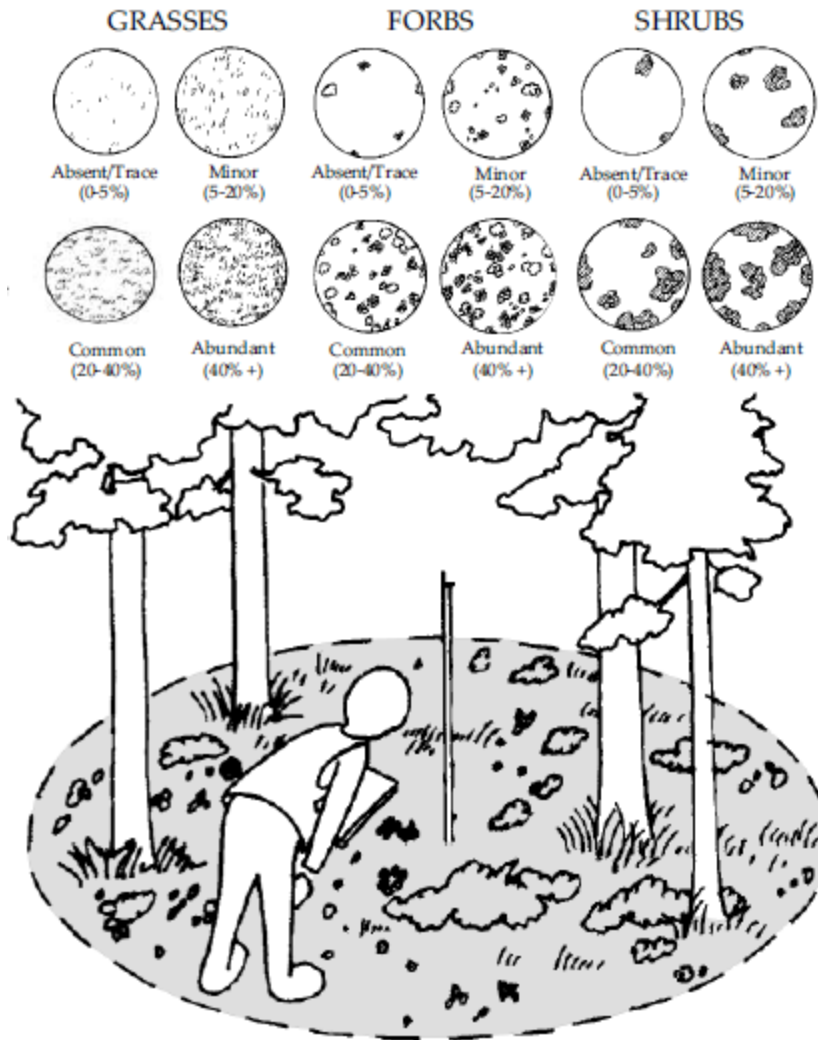
Example of vegetation cover that divides out Grasses, Shrubs, and Forbs (MSU Extension Service).

- Estimate the % ground cover of revegetation for all vegetation (grasses, forbs, shrubs, and trees)  
TR): Absent/Trace (0-5%); MI): Minor (5-20%); CO): Common (20-40%); or AB): Abundant (40%+)
